# Environmental Screening for Surface SARS-CoV-2 Contamination in Urban High-Touch Areas

## Abstract

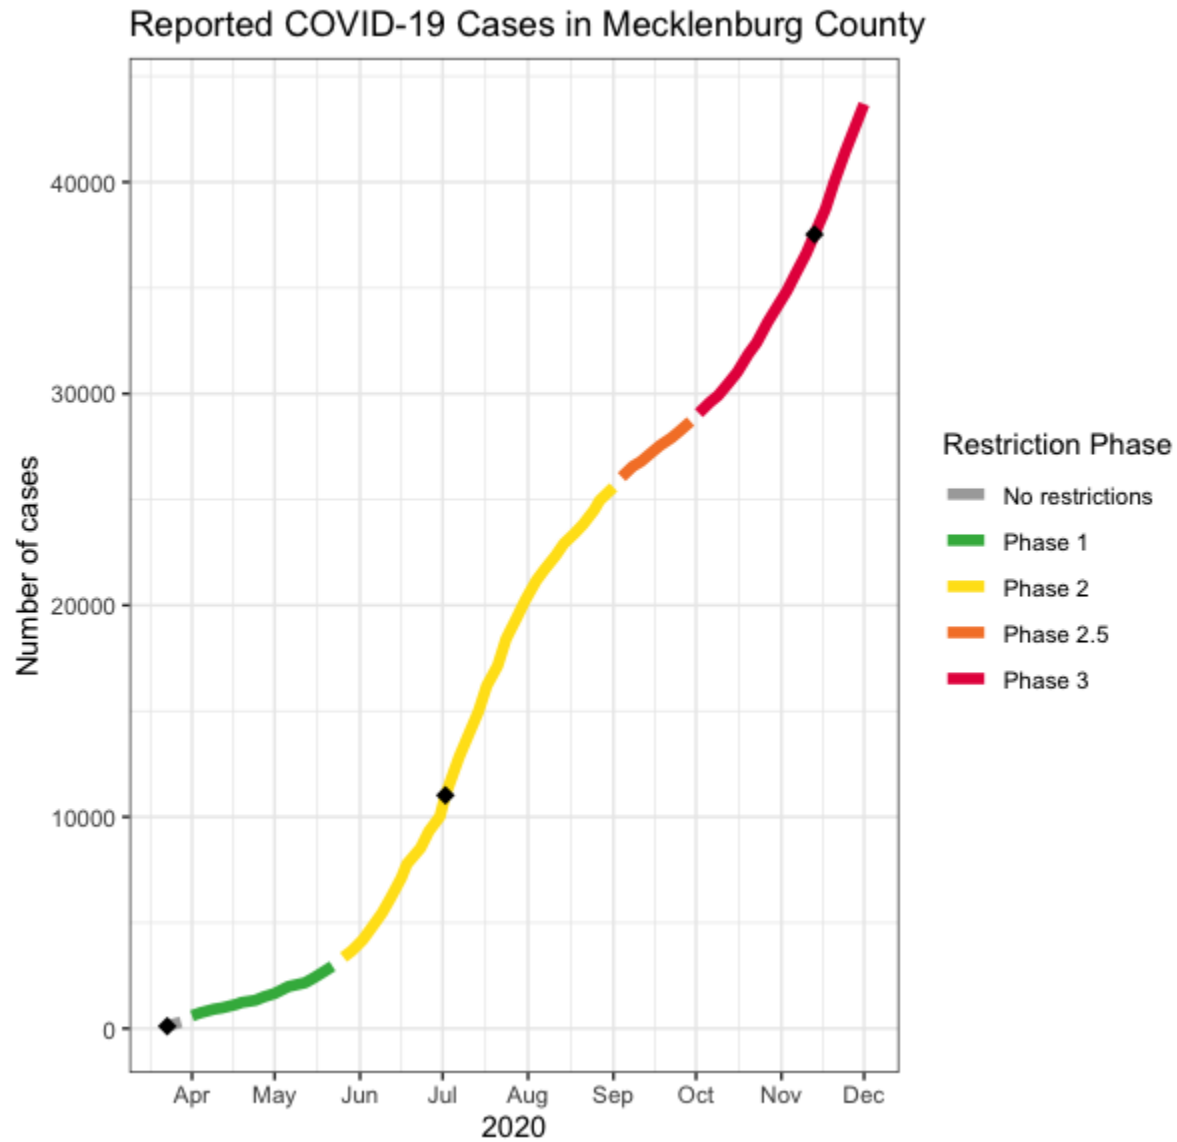
**Figure 1.** Graphical representation of Mecklenburg County’s reported COVID-19 cases over the 2020 pandemic period. The trendline of cases is segmented by the advent of restriction phases, and black diamond marks indicate when surface samples were collected.

For this study, we collected samples from high-touch surfaces at three different time points during the pandemic [Figure 1]. As the University was closing down and students were moving off campus, we swabbed high-touch surfaces on campus buses as well as surfaces in public areas where students frequently gather. In Phase II, during late July, we swabbed high-touch surfaces on CATS buses, Lynx light rail train cars, and paratransit vehicles. Samples were collected at the end of daily operations, before vehicles were cleaned and sanitized. In Phase III, during mid-November, we again collected samples from CATS vehicles, this time both before and after cleaning. Samples were analyzed using PCR-based molecular detection with standard CDC research use only (RUO) reagents [16]. While a small number of SARS-CoV-2 positive samples were detected among various sites during Phase I and Phase III, the vast majority of sites sampled were free from detectable contamination with SARS-CoV-2.

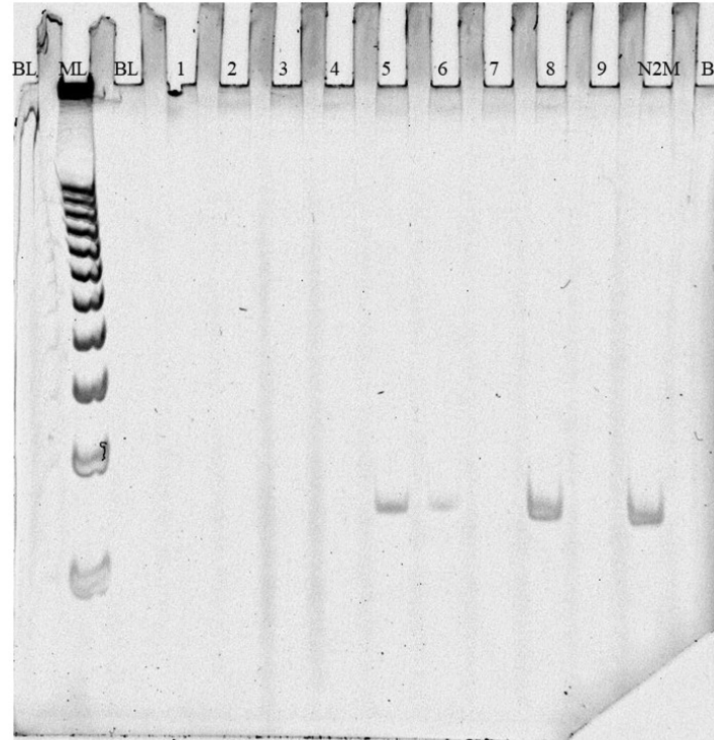
**Figure 2.** Example acrylamide gel image depicting all components indicative of a successful experiment. In this image, the first and last lanes labeled “BL” are negative controls loaded with nuclease-free water, and the lane labeled “ML” contains a 25 base pair ladder. IDT’s 2019-nCov’s specific N2 primer produces a PCR product that is 67 base pairs in length, seen in lane “N2M” for positive control purposes. Bands at the same location are considered to have tested positive for SARS-CoV-2, seen in lanes 5 and 6. These lanes contain the positive PCR product of experimental samples collected from stainless steel door handles to a student residence hall, as well as the university’s heavily populated Student Union.

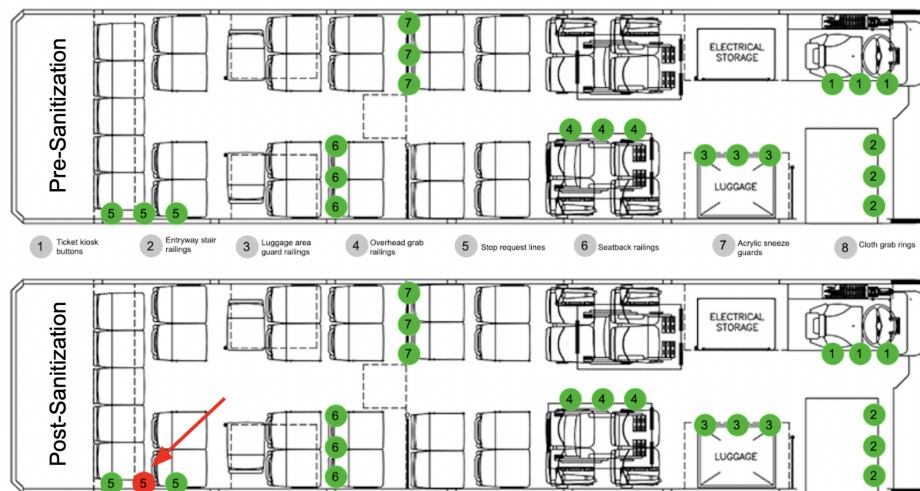
**Figure 3.** Illustration of sampling locations on the CATS buses [18]. Sites are labeled 1-8 on each vehicle, both before and after routine sanitization. A site with a green dot indicates that there was no presence of SARS-CoV-2 RNA recovered from the surface, and a site with a red dot indicates that there was presence of SARS-CoV-2 RNA recovered from the surface. Here, the stop request line at the back of bus 2 after cleaning tested positive for the presence of SARS-CoV-2 RNA.

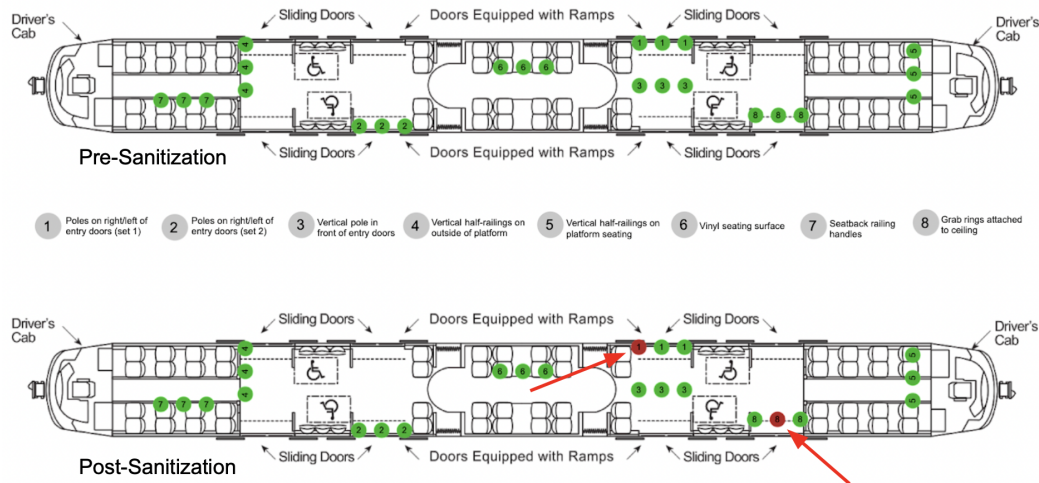
**Figure 4.** Illustration of sampling locations on the CATS Light Rail trains [19]. Sites are labeled 1-8 on each vehicle, both before and after routine sanitization. A site with a green dot indicates that there was no presence of SARS-CoV-2 RNA recovered from the surface, and a site with a red dot indicates that there was presence of SARS-CoV-2 RNA recovered from the surface. Here, the poles on the right/left of the entry doors on train 1 and the grab rings attached to the ceiling on train 2 tested positive for the presence of SARS-CoV-2 RNA.

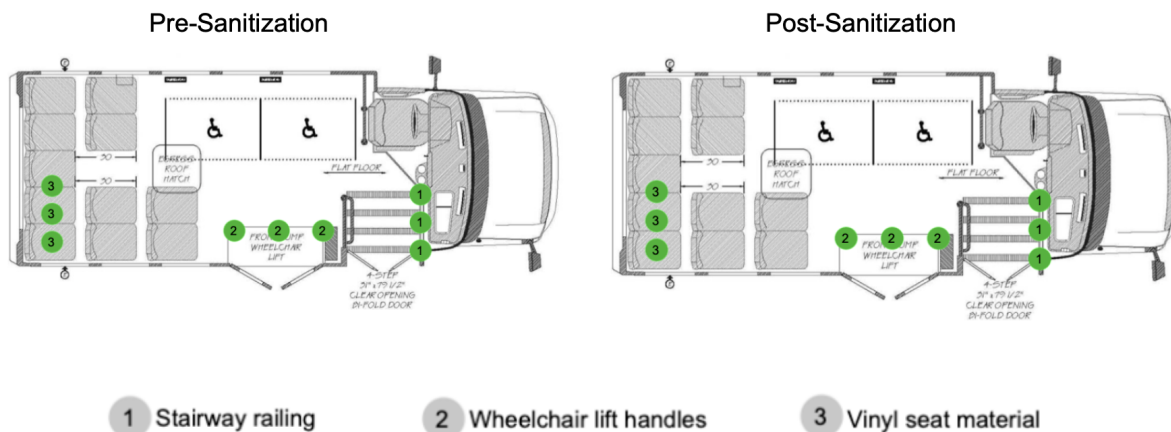
**Figure 5.** Illustration of sampling locations on the CATS paratransit vehicles [20]. Sites are labeled 1-3 on each vehicle, both before and after routine sanitization. A site with a green dot indicates that there was no presence of SARS-CoV-2 RNA recovered from the surface, and a site with a red dot indicates that there was presence of SARS-CoV-2 RNA recovered from the surface.

In order for a sample to be considered positive, each of the three replicates from the qPCR assay must show that it has crossed the cycle threshold (Cq) at or below 40 cycles per CDC guidelines [15]. The samples collected on the stop request line on the second bus showed Cq values consistent with a positive in all three wells for the N2 primer pre-sanitization [Figure 3; Table 6], and the grab rings on the samples collected from the second train showed Cq values consistent with a positive for all three wells for the N1 primer post-sanitization [Figure 4; Table 6]. The sample collected on the grab poles on the right/left of the entryway doors on the first train showed Cq values consistent with a positive result in all three wells for both the N1 and N2 primer, post-sanitization [Figure 4; Table 6]. None of the samples collected from the paratransit vehicles showed any signal in the qPCR analyses using IDT's N1 or N2 primer [Figure 5; Supplementary Table 2].

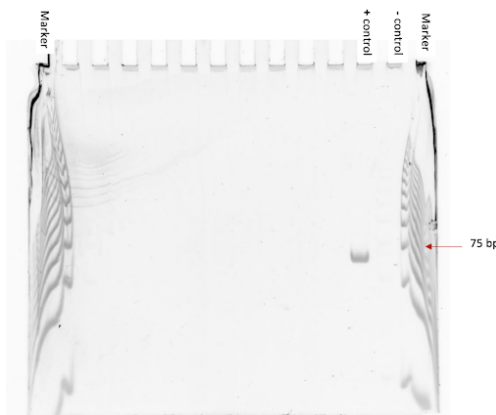
**Supplementary Figure 1.** Example gel image depicting all components indicative of a successful experiment. In this image, the first and last lanes contain the 25 base pair ladder, the 75bp band is indicated. The 2019-nCoV's specific N1 primer produces a PCR product that is 72bp in length, and the 2019-nCoV's specific N2 primer produces a PCR product that is 67bp in length. The second to last lane containing the negative control is completely blank, and the positive control shows a band around the 75 base pair mark. A band here indicates a positive result; in the case of our experiment, this would indicate that there is presence of SARS-CoV-2 viral RNA.

At the beginning of the pandemic, we were able to demonstrate that the endpoint PCR method performed as expected [Supplementary Figure 1], and to successfully detect the presence of SARS-CoV-2 RNA [Figure 2] from surface samples collected on campus using endpoint PCR alone. This method detected SARS-CoV-2 in 11 of 70 samples using the RUO N2 primers, from locations on campus at UNCC [Table 3; Table 4; Figure 2]. Of the 11 that were deemed positive using the endpoint PCR detection method, 3 of those were later confirmed positive for SARS-CoV-2 using the qPCR detection method [Table 5].

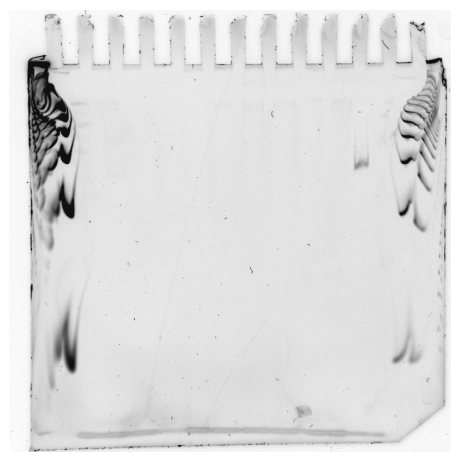
M 1T1 1T2 1T3 1T4 1T5 1T6 1T7 2T1 2T2 2T3 + - M

**Supplementary Figure 2.** Plate 1; row A (all gels for public transit vehicles in Phase II look like this)
