# Microbial contamination of powered air purifying respirators (PAPR) used during the COVID-19 pandemic: an in situ microbiological study

In situ microbiological study. Single NHS Trust, UK.

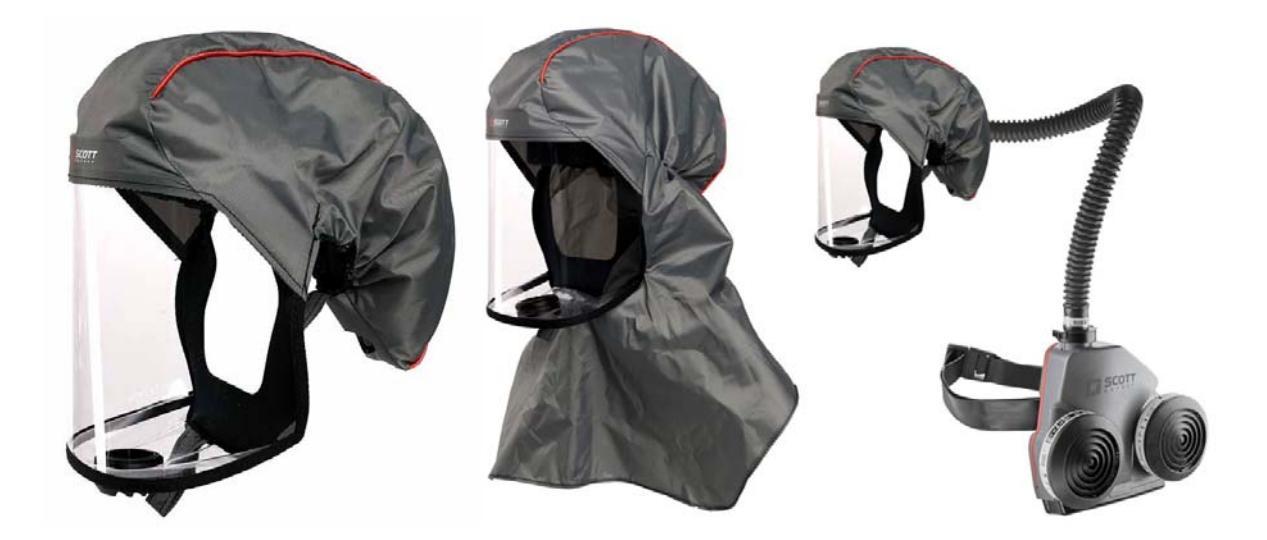
## Figure 1. 3M Scott FH1 and FH2 Headtops and PAPR arrangement

There are currently approximately 100 PAPRs in our Trust; PAPR assemblies consist of a fan unit with battery pack and filters, connected via corrugated tubing to a headtop or hood (figure 1). The majority of hoods are *3M Scott Safety FH1* headtops, the rest are *3M Scott Safety FH2 PAPR headtops* (3M Scott, Skelmersdale, UK). The *3M Scott Safety FH1* headtop is a half hood that provides a loose seal around the face; the *3M Scott Safety FH2 PAPR headtop* is the similar to the *FH1* but, in addition, has a shoulder cape that provides neck and shoulder protection. The filtered air, under positive pressure is supplied to the wearer; this and the wearer's exhaled breath is expelled around the edges of the hood and through an unshrouded expiratory valve at the bottom of the visor component of the hood. The hoods consist of a clear polyethylene terephthalate glycol visor, stitched to fabric, with a neoprene margin that sits against the wearers face. These PAPR and hoods were originally developed to provide respiratory protection in industrial use to help combat pulmonary contamination by inanimate particulates; their use has been adapted for the current circumstances during the COVID-19 pandemic by upgrading the filters attached to the fan unit.

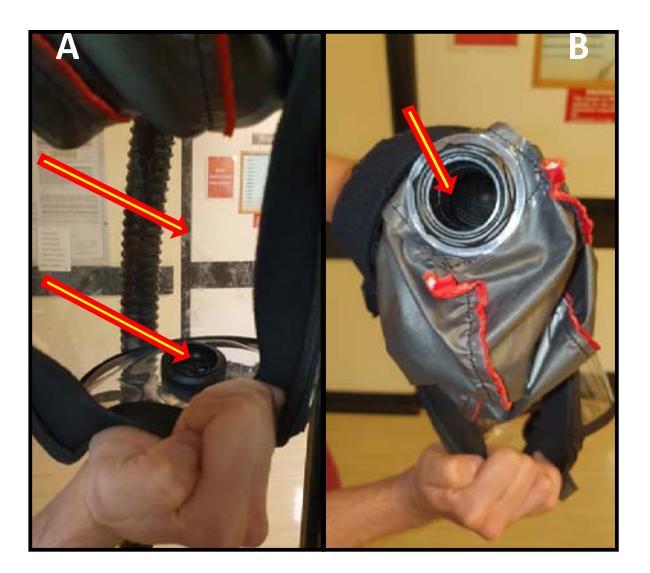
- 1. Identify power hood
- 2. Label power hood (same name as sample)
  - E.g. Pye\_PRH\_1 (Pyecombe, PRH, Hood 1)
  - E.g. ICU\_RSCH\_3 (ICU, RSCH, Hood 3)
- 3. Don PPE:
  - Hood holder fresh sterile gloves, eye protection, and FFP3 respirator
  - Swab taker fresh sterile gloves, eye protection, and FFP3 respirator
  - Swab labelling & bagger non-sterile gloves, eye protection, and FFP3 respirator
- 4. Prepare power hood and hold as per illustration

- plastic visor and the exhalation vent
  - ▶ take **BLACK** (bacterial/fungal) swab and drip on sterile 0.9% NaCl
    - Wipe swab over (inside of) clear face piece and expiration vent
  - ► take GREEN (viral/COVID) swab and drip on sterile 0.9% NaCl
  - Wipe swab over (inside of) clear face piece and expiration vent
- Corrugated tube at hood end
  - ▶ take **BLACK** (bacterial/fungal) swab and drip on sterile 0.9% NaCl
    - Wipe swab around and 10 cm in to corrugated tube
  - ➤ take GREEN (viral/COVID) swab and drip on sterile 0.9% NaCl
    - Wipe swab around and 10 cm in to corrugated tube
- 6. Labelling samples
  - E.g. Pye\_PRH\_1\_Bact/Fung\_visor = Pyecombe, PRH, Hood 1, bacterial/fungal swab from visor
  - E.g. ICU\_RSCH\_3 \_Viral\_tube = ICU, RSCH, Hood 3, viral & COVID swab from corrugated tube
- 7. Bagging
  - Each sample must go in its own labelled bag

The hood-holder manipulated the mask to allow the swab-taker access to the target area to take samples (Figure 2). Each PAPR was swabbed for bacteria, fungi, respiratory viruses (extended respiratory panel) and SARS-CoV-2. Bacterial and fungal samples were taken with Transwab® Amies Charcoal swabs (MW171, Medical Wire & Equipment, UK), and viral samples taken with Sigma Virocult® swabs (MW951S, Medical Wire & Equipment, UK).
