Toilets dominate environmental detection of SARS-CoV-2 virus in a hospital

Abstract

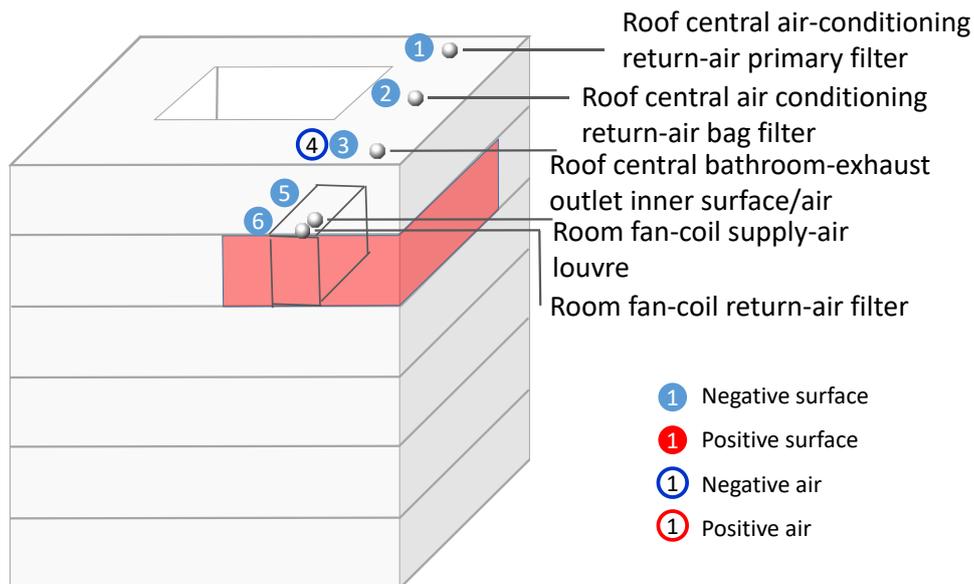
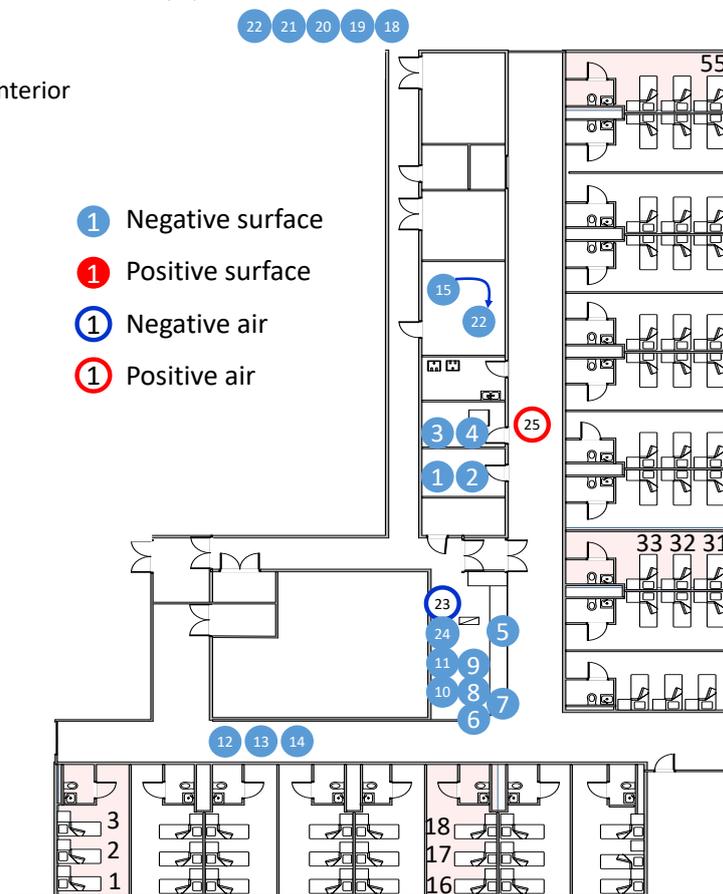
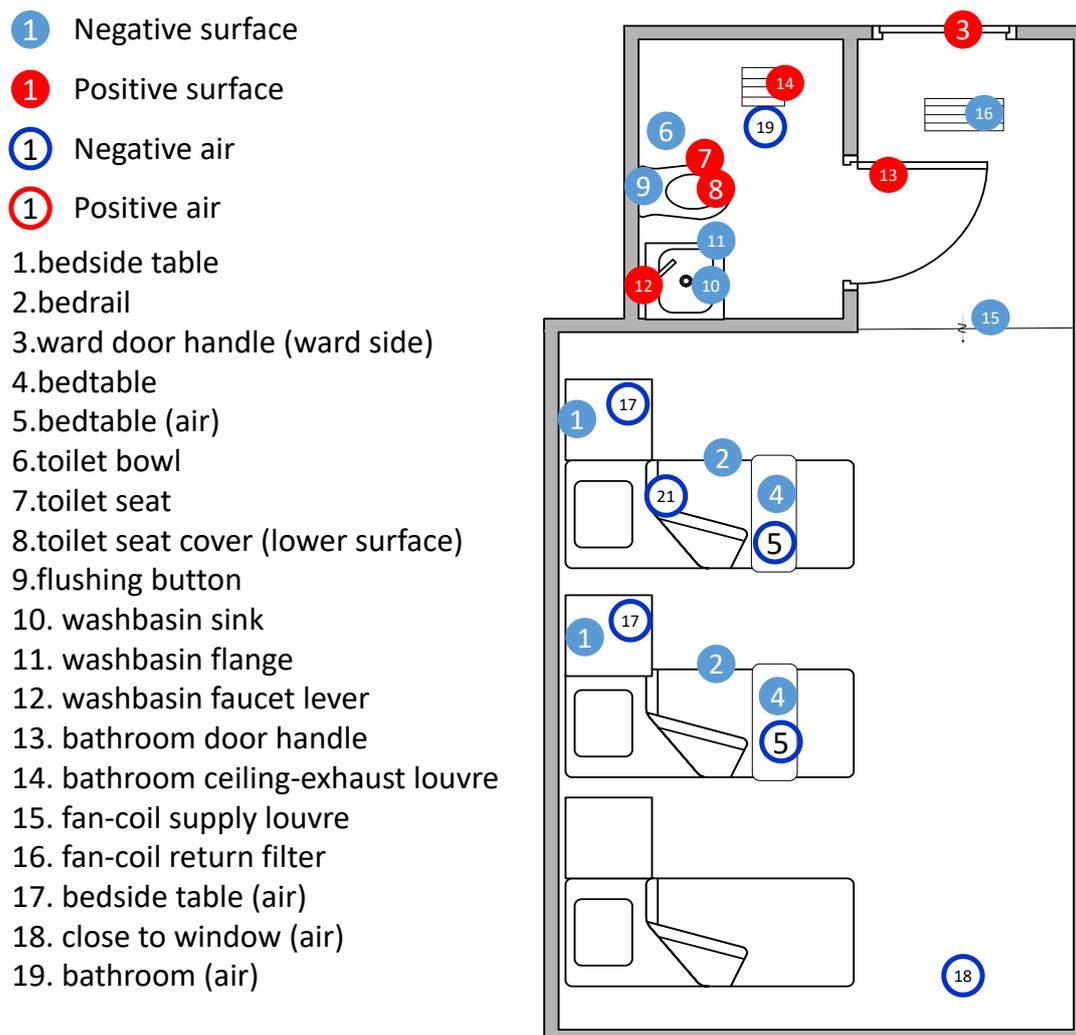
1. cleaner's: mop
2. squeeze mop
3. Storage room: medical waste-bin (interior surface)
4. medical waste-bin pedal
5. nursing station: front desk
6. door handle
7. disinfectant-station button
8. computer keyboard
9. operating clinical desk
10. phone
11. hand-disinfectant spray button
12. corridor: nurses' trolley handle
13. nurses' tray
14. handrail
15. change room: desk
16. Floor
17. hand-disinfectant spray button
18. waste-bin interior surface
19. waste-bin pedal
20. washbasin sink
21. washbasin flange
22. washbasin surface
23. nursing station: below air-supply inlet (air)
24. nursing station: below air-supply inlet (surface)
25. corridor outside storage room

Figure 1. Summary of the sites where the air and surface samples were taken in the hospital. (A) In the air-conditioning systems of the isolation rooms and on the building roof. The highlighted area in red is the airborne infectious disease zone on the 5th floor; (B) at the nursing station, storage/cleaner’s rooms, healthcare workers’ PPE changing room, and corridor; and (C) in the isolation rooms, but note that in some of the rooms, fewer surface and air samples were taken than are shown here. The positive samples are shown by either empty circle in red or filled circle in red. The negative samples are shown by either empty circle in blue or filled circle in blue. In Figure 1B, the four sampled rooms are highlighted in light red, i.e. isolation rooms containing beds 2 and 3, beds 16-18, beds 31 and 32, and bed 55.

The sites for the air and surface samples are shown in [Figure 1](#). All samples were collected by a trained CDC officer who had a medical background, assisted by two trained nurses from the hospital. The CDC officer wore full personal protective equipment (PPE), namely an N95 respirator, goggles, face shield, gloves, shoe covers, cap, and gown. He was quarantined for 12 days after the collection on 8 February, disinfected, and resumed sampling on 20 and 22 February. Thereafter he was quarantined again for another 14 days, and again disinfected.

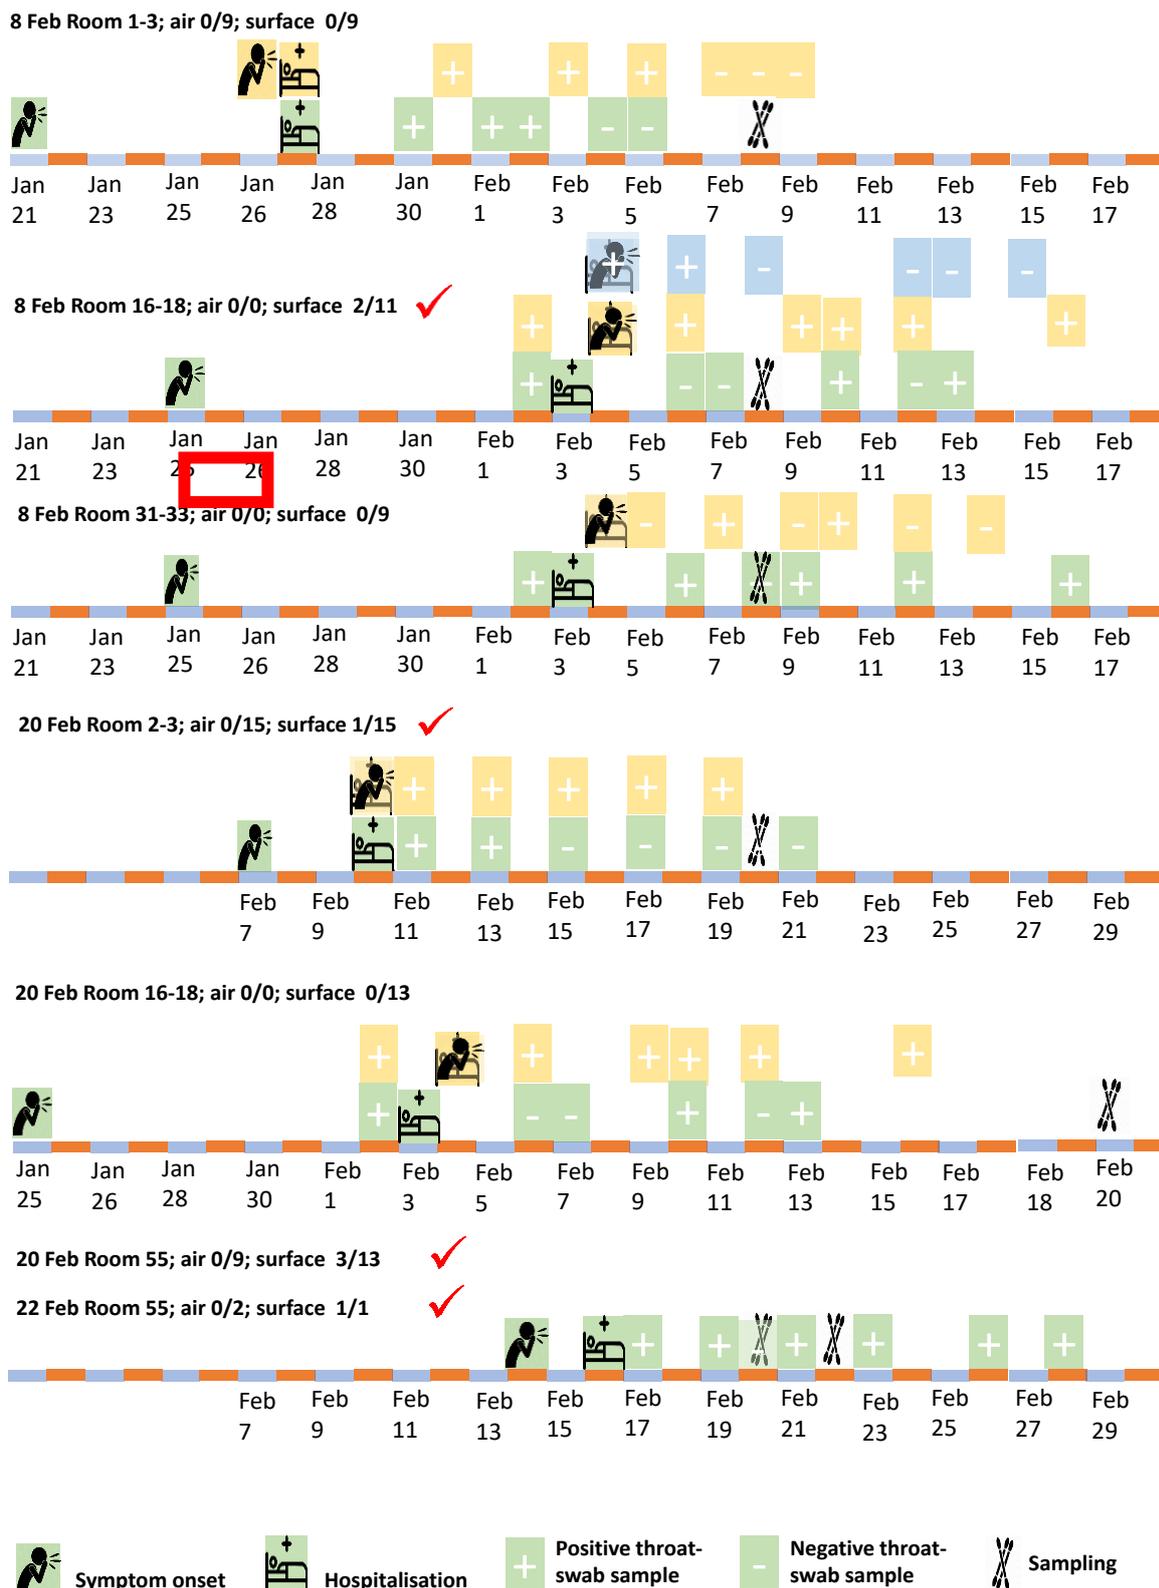
Figure 2. Summary of the isolation rooms containing beds 2 and 3, beds 16-18, beds 31 and 32, and bed 55, and their 10 patients (onset and hospitalisation dates), and the sampling dates. The sampling dates on which positive samples were detected are also shown by a red tick. In each room, a patient and his/her bed are shown in the same colour. When events occurred on the same day, such as symptom onset and hospitalisation, the symbols overlap and are shown in transparent style.

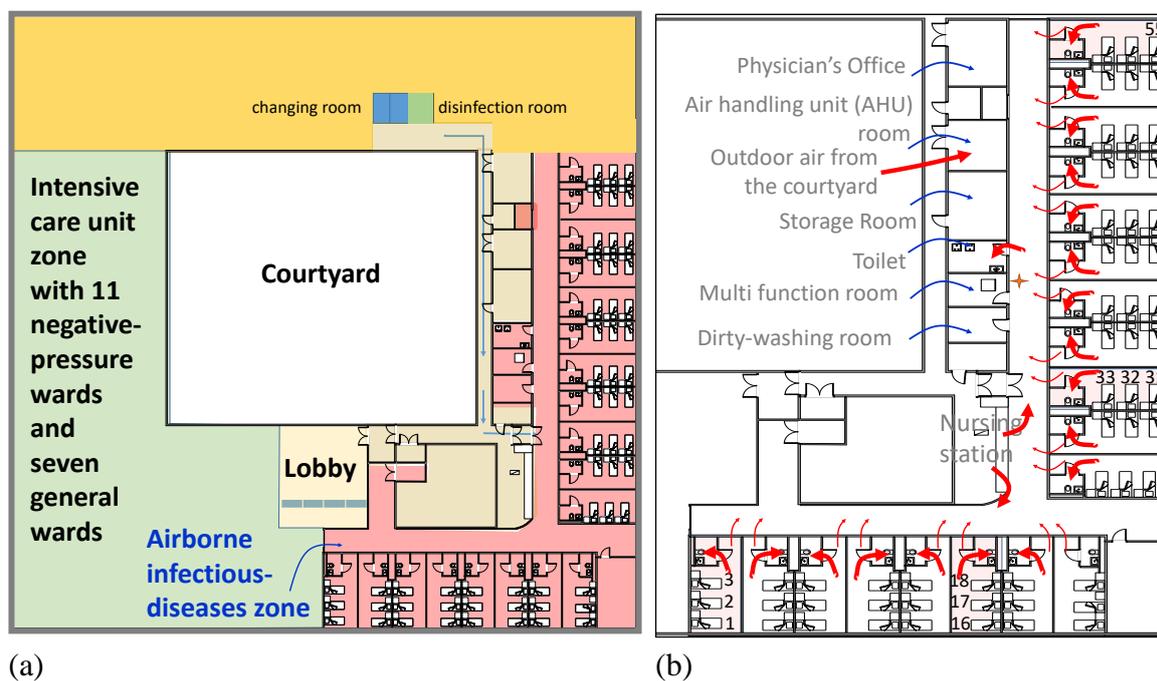
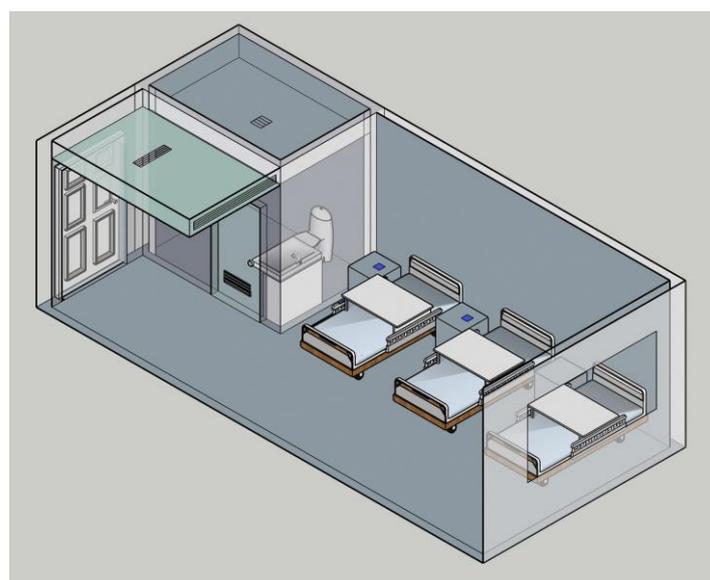
Figure S1. (a) Floor plan of the fifth floor of the hospital, with the airborne infectious-disease zone shown in transparent pink. (b) Floor plan of the airborne infectious-disease zone showing the location of the sampled isolation rooms (with beds 1-3; beds 16-18; beds 31-33; bed 55 shown), nursing station, and other rooms. The general airflow pattern is shown by red arrows. (c) Three-dimensional perspective view of the isolation room, showing the location of various objects.
