Microbial contamination of powered air purifying respirators (PAPR) used during the COVID-19 pandemic: an in situ microbiological study

To determine whether internal components of powered air purifying respirators (PAPR) used during the Corona virus 2019 disease (COVID-19) pandemic are contaminated with bacteria, fungi and/or any viral material.

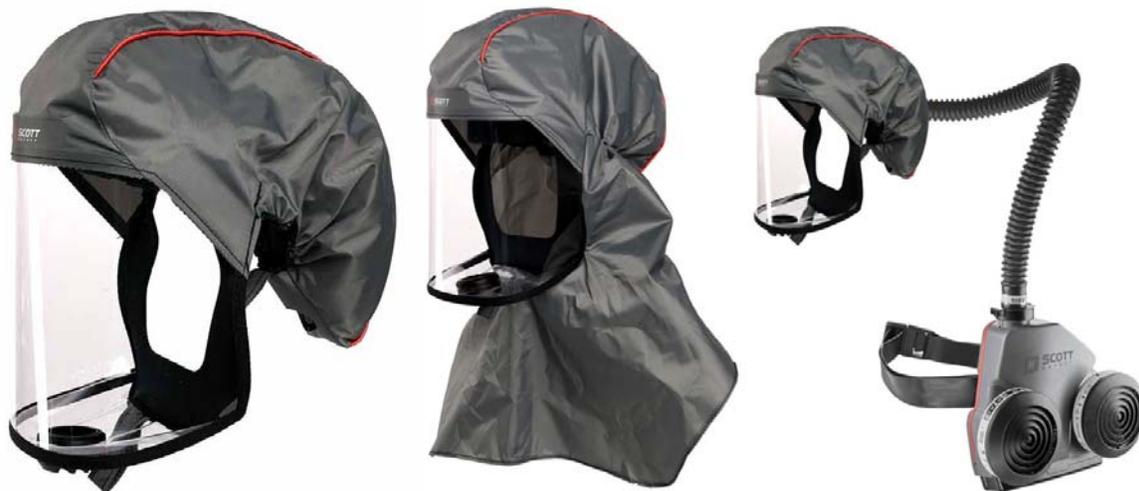
Figure 1. 3M Scott FH1 and FH2 Headtops and PAPR arrangement

There are currently approximately 100 PAPRs in our Trust; PAPR assemblies consist of a fan unit with battery pack and filters, connected via corrugated tubing to a headtop or hood (figure 1). The majority of hoods are *3M Scott Safety FH1 headtops*, the rest are *3M Scott Safety FH2 PAPR headtops* (3M Scott, Skelmersdale, UK). The *3M Scott Safety FH1 headtop* is a half hood that provides a loose seal around the face; the *3M Scott Safety FH2 PAPR headtop* is similar to the *FH1* but, in addition, has a shoulder cape that provides neck and shoulder protection. The filtered air, under positive pressure is supplied to the wearer; this and the wearer's exhaled breath is expelled around the edges of the hood and through an unshrouded expiratory valve at the bottom of the visor component of the hood. The hoods consist of a clear polyethylene terephthalate glycol visor, stitched to fabric, with a neoprene margin that sits against the wearers face. These PAPR and hoods were originally developed to provide respiratory protection in industrial use to help combat pulmonary contamination by inanimate particulates; their use has been adapted for the current circumstances during the COVID-19 pandemic by upgrading the filters attached to the fan unit.

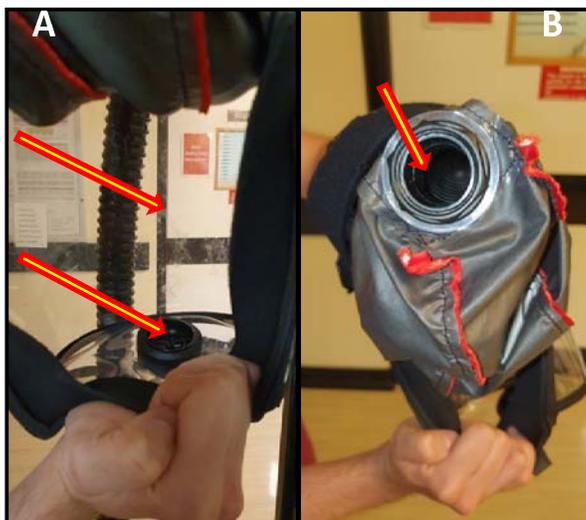
1. Identify power hood
2. Label power hood (same name as sample)
 - E.g. Pye_PRH_1 (Pyecombe, PRH, Hood 1)
 - E.g. ICU_RSCH_3 (ICU, RSCH, Hood 3)
3. Don PPE:
 - Hood holder – fresh sterile gloves, eye protection, and FFP3 respirator
 - Swab taker – fresh sterile gloves, eye protection, and FFP3 respirator
 - Swab labelling & bagger – non-sterile gloves, eye protection, and FFP3 respirator
4. Prepare power hood and hold as per illustration

5. Swabbing
 - plastic visor and the exhalation vent
 - take **BLACK** (bacterial/fungal) swab and drip on sterile 0.9% NaCl
 - Wipe swab over (inside of) clear face piece and expiration vent
 - take **GREEN** (viral/COVID) swab and drip on sterile 0.9% NaCl
 - Wipe swab over (inside of) clear face piece and expiration vent
 - Corrugated tube at hood end
 - take **BLACK** (bacterial/fungal) swab and drip on sterile 0.9% NaCl
 - Wipe swab around and 10 cm in to corrugated tube
 - take **GREEN** (viral/COVID) swab and drip on sterile 0.9% NaCl
 - Wipe swab around and 10 cm in to corrugated tube
6. Labelling samples
 - E.g. Pye_PRH_1_Bact/Fung_visor = Pyecombe, PRH, Hood 1, bacterial/fungal swab from visor
 - E.g. ICU_RSCH_3_Viral_tube = ICU, RSCH, Hood 3, viral & COVID swab from corrugated tube
7. Bagging
 - Each sample must go in its own labelled bag

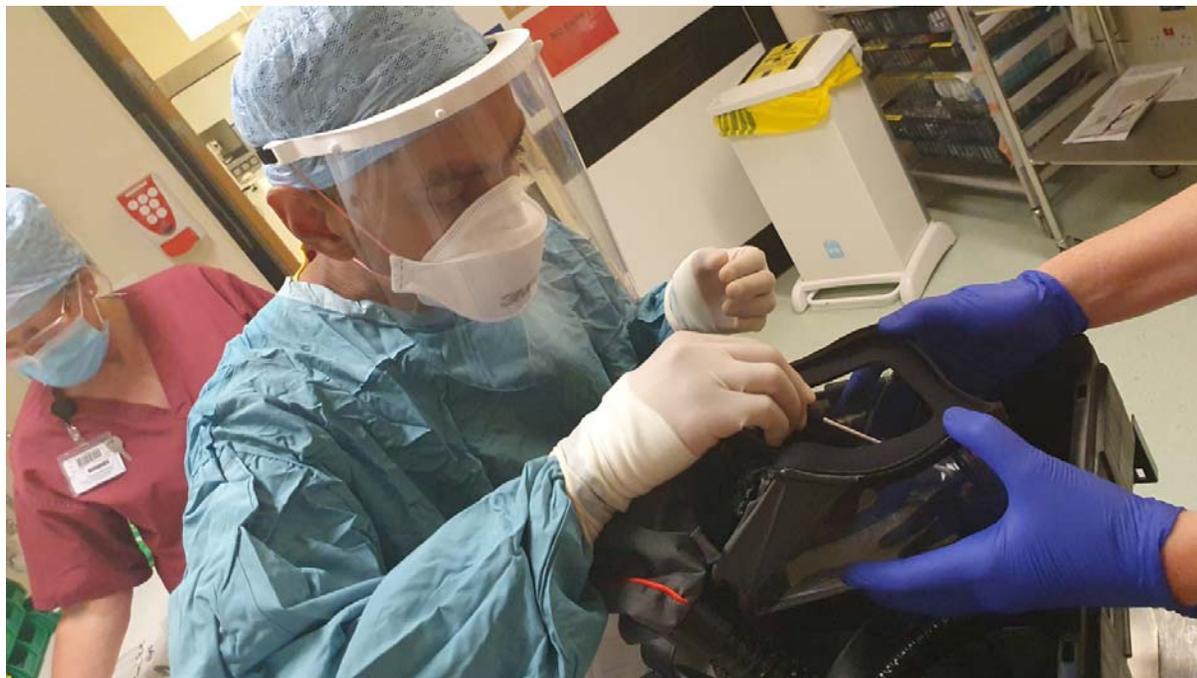
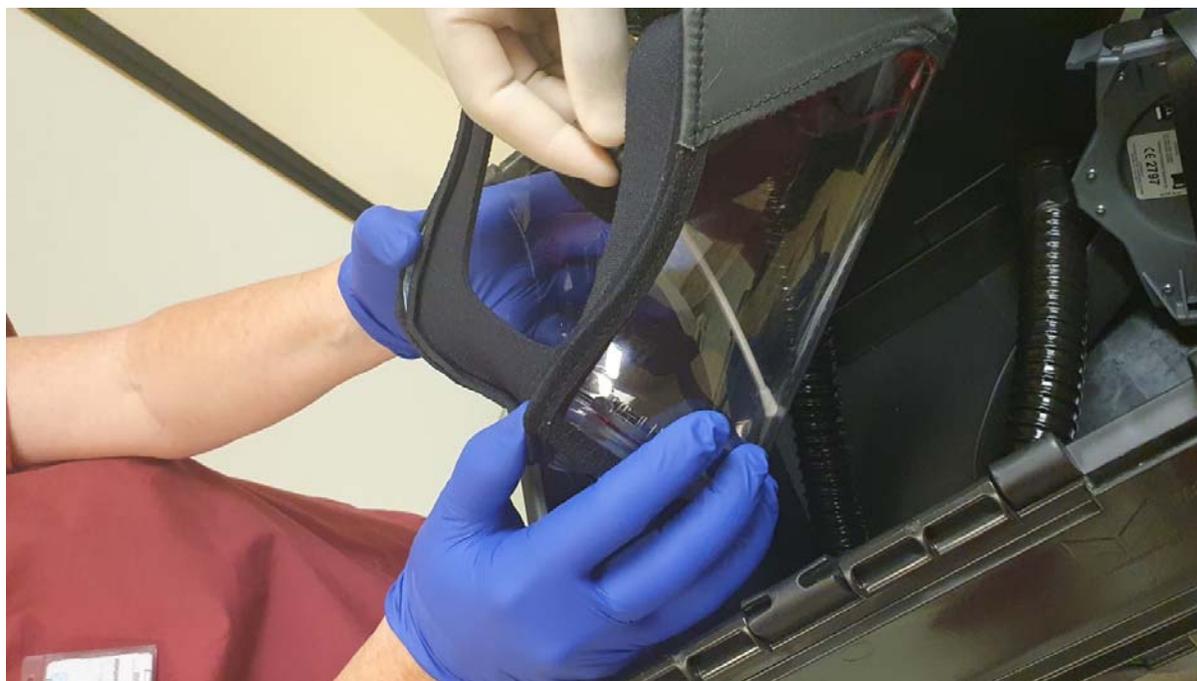
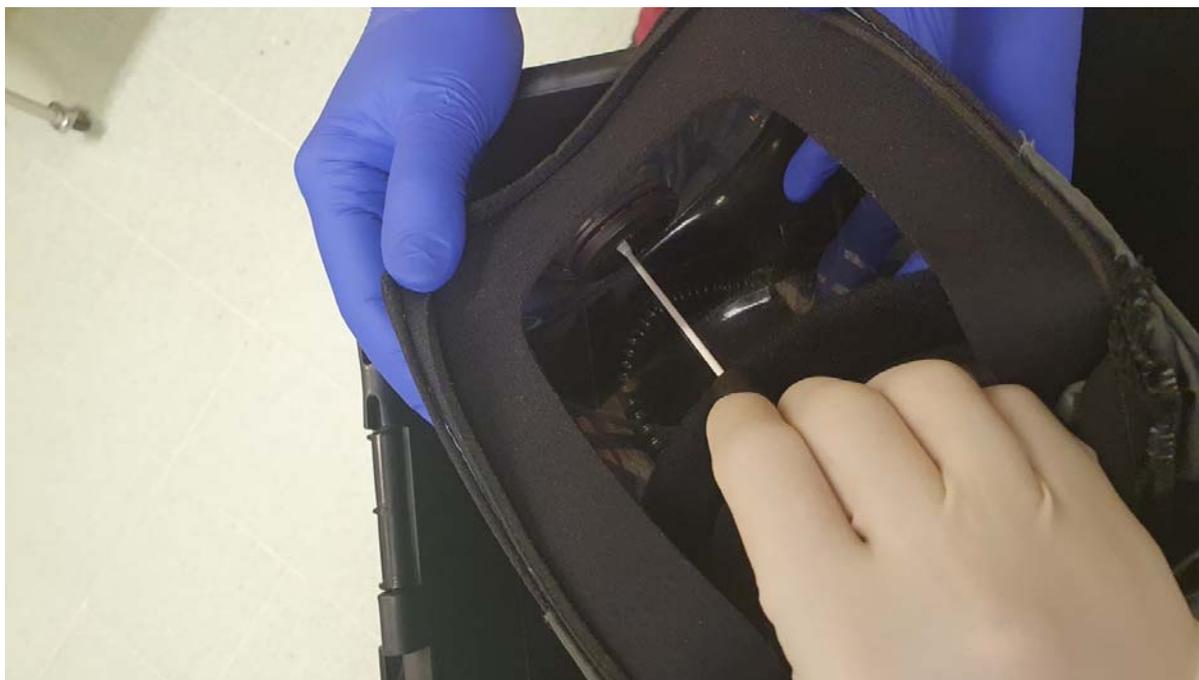
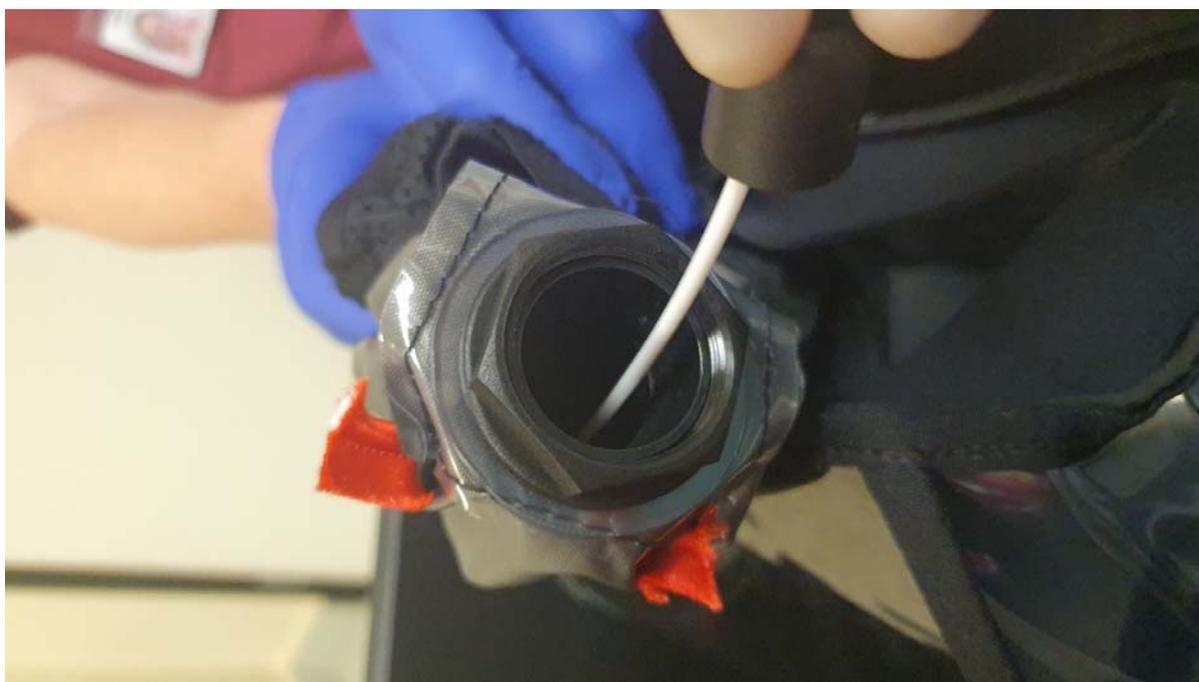
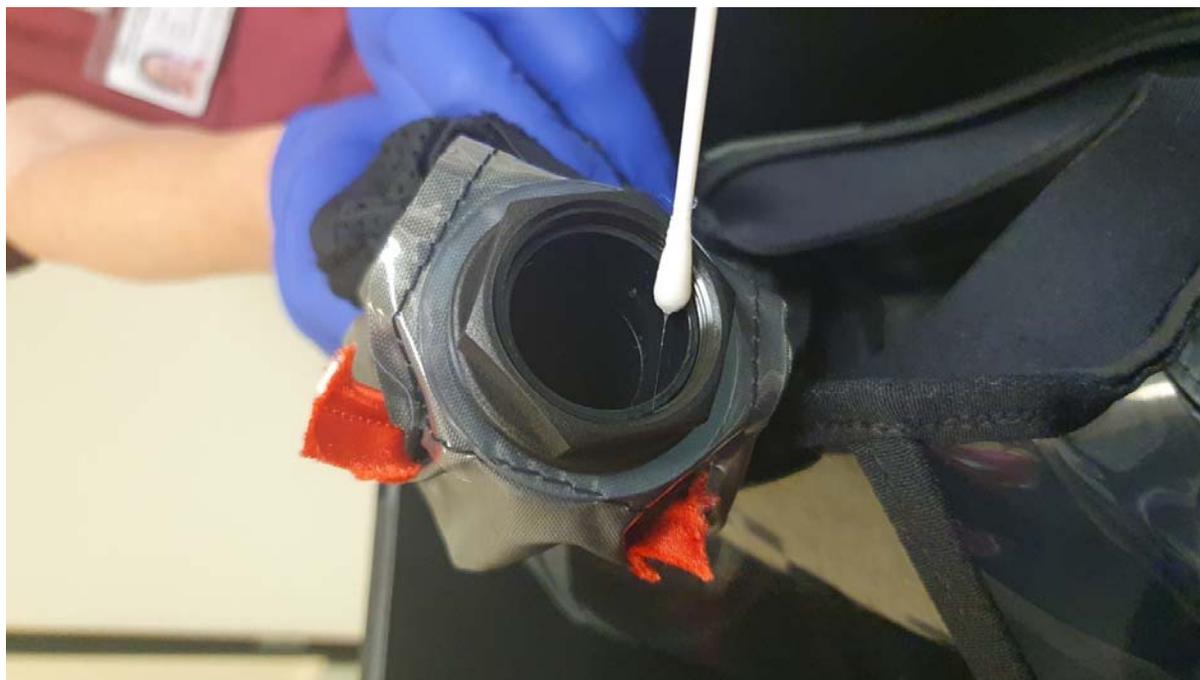
Supplementary information 3. Swabbing PPR hoods and tubing (simulated)

The hood-holder manipulated the mask to allow the swab-taker access to the target area to take samples (Figure 2). Each PAPR was swabbed for bacteria, fungi, respiratory viruses (extended respiratory panel) and SARS-CoV-2. Bacterial and fungal samples were taken with Transwab® Amies Charcoal swabs (MW171, Medical Wire & Equipment, UK), and viral samples taken with Sigma Virocult® swabs (MW951S, Medical Wire & Equipment, UK).

Swabs were moistened with sterile 0.9% sodium chloride solution. Swabs were taken from two pre-defined areas: first, inside of the clear plastic visor including the expiratory valve, and second, inside the corrugated tube attached to the hood. The visor and expiratory valve were divided into two halves, one for the charcoal swab and one for the viral swab. The expiratory valve was swabbed first with care taken to apply the swabs uniformly over the surface and then over the respective side of the visor in linear, up-down, fashion with care taken to access any corners and cover the full area of the visor. The corrugated tubes were also divided into two halves, one for each type of swab. The swab was passed from the rim down to approximately 10cm, the length of the swabs, with care taken to swab within the ridges of the corrugations.
