Flushing water regularly inadequate to protect water qual-

2 ity in gravity-fed water supply systems with storage tanks

3 during long-term lockdown

- 4 Deepika Bhaskar¹, Gargi Singh¹*
- ¹Department of Civil Engineering, Indian Institute of Technology Roorkee, Roorkee-247667,
- 6 India

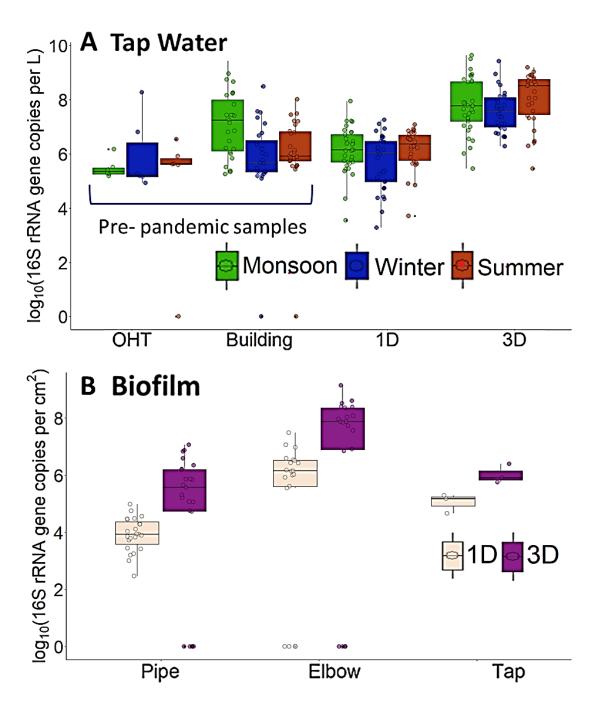
Fig. 1. The levels of 16S rRNA gene copies in tap water samples collected from **A.** prepandemic OHT, buildings, and laboratory scale premise water supply network in three seasons (summer, monsoon and winter) and, **B.** Biofilm samples swabbed from surfaces of pipes, elbows and taps subjected to 1D and 3D approaches; Prefixes 1D and 3D refer to water drawn once per day and once in three days respectively

tap water and the biofilms samples under the 3D approach were 2-3 orders of magnitude higher relative to the 1D approach, the OHT, and the building samples (p<0.05, One-tailed Wilcoxon signed-rank test, Figure 1 & S13). There was no difference in the levels of 16S rRNA gene copies in the tap water from 1D and the buildings under routine occupation before the pandemic (p= 0.4, One-tailed Wilcoxon signed-rank test). The levels of 16S rRNA gene copies in the tap water varied throughout the duration of the operation of the laboratory-scale premise water supply network (p=0.01, Augmented Dickey-Fuller test) under both the 1D and 3D approaches: During the first 120 days of operation, which coincided with the monsoon month (water temperature: 23°C – 25°C; July to September), the levels of 16S rRNA gene copies increased by an order of magnitude in 1D, and 3-4 orders of magnitude in 3D (Figure 1A). Between day 120 - day 230 of the operation, which coincided with the winter months (water temperature: 12°C – 16°C, late October to March), the levels of 16S rRNA gene copies decreased an order of magnitude in 1D (Figure 1A, p= 0.001, One-tailed Wilcoxon signed-rank test), and had a slight but statistically insignificant decrease in 3D (Figure 1A, p= 0.08, One-tailed Wilcoxon signed-rank test). Over the next 136 days (day 230 – day 365 of the operation), which coincided with summer months (water temperature: 28°C – 35°C; March to June), the levels of 16S rRNA gene copies increased two orders of magnitude in both 1D (p= 0.001, One-tailed Wilcoxon signed-rank test) and 3D (p= 0.002, One-tailed Wilcoxon signed-rank test) (Figure 1A). The levels of 16S rRNA gene copies in the tap water weakly but significantly correlated with the levels of Fe in 1D (r= 0.25, Spearman's rank correlation); and with chloride (r=0.29) and sulphate (r=0.29) in 3D (Figure 5A). The levels of 16S rRNA gene copies per unit area in the biofilms from 3D were 2-3 orders of magnitude higher relative to 1D (p<0.05, One-tailed Wilcoxon signed-rank test, Figures 1B & S13B). Within the laboratory-scale premise water distribution system, the biofilm samples

from the elbows had two orders of magnitude higher levels of 16S rRNA gene copies relative to visibly-corroded pipe-sections for both 1D (p<0.05, One-tailed Wilcoxon signed-rank test, Figure 1B) and 3D approaches (p=0.0003, One-tailed Wilcoxon signed-rank test, Figures 1B & S13B). The biofilm sample taken from the elbows that were farthest from the secondary storage tank under the 3D approach, and elbows that were second to last from the secondary storage tank under the 1D approach had the highest level of 16S rRNA gene copies per unit area (Figures S14A & S15A).

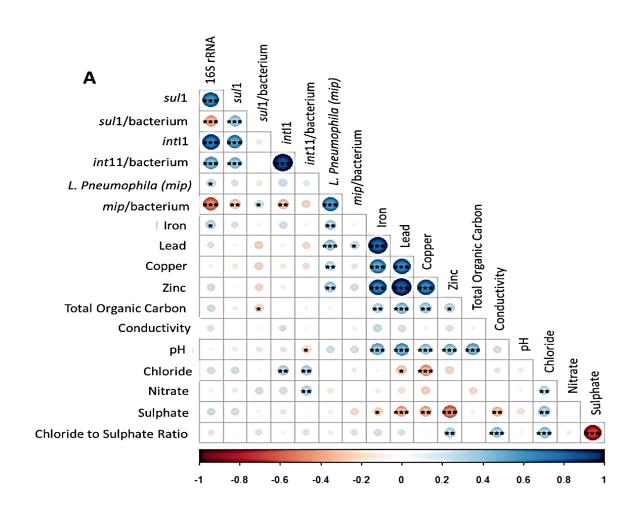
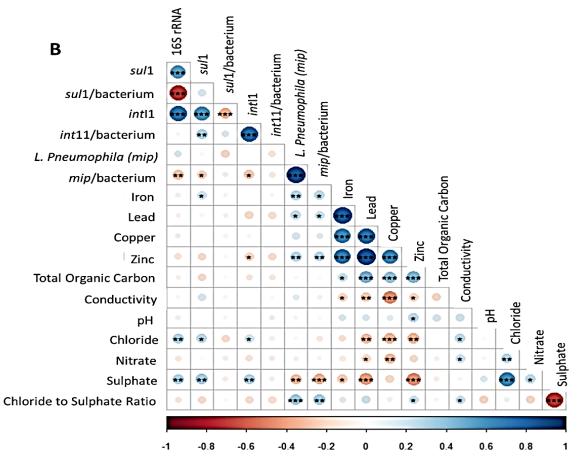
Fig. 5. Correlogram of Spearman's rank correlation coefficients computed between the relative concentration of targeted genes and physicochemical parameters in all samples in A. 1D and, B 3D laboratory scale premise water supply network (*: P-value < 0.05, **: P-value < 0.01, ***: P-value < 0.001)

significantly higher under the 1D approach (-6.2 to -0.15 on the log10 scale) relative to the 3D approach (-7.9 to -0.76 on $\log 10$ scale), trending similarly as the relative levels of sul1. The relative levels of *int*I1 in winter and summer seasons in 1D (-6.2 to -2.8 on the log10 scale) were 2-3 orders of magnitude higher compared to the building samples (-6.8 to -0.79on the log10 scale) (p<0.05, One-tailed Wilcoxon signed-rank test, Figure 3A). During the monsoon season, the absolute and relative levels of *int*I1 under the 1D approach and in building samples were comparable (Figure 3A). Similar to the 16S rRNA gene copy levels, the absolute levels of sul1 and intI1 varied throughout the year-long operation. In both 1D, the absolute levels of both sul1 and intI1 increased slightly for the first 230 days, followed by a slight dip during the winter season and an insignificant rise during the summer season (p>0.5, One-tailed Wilcoxon signed-rank test), while in 3D a significant drop was seen in winter for intI1 (p<0.05, One-tailed Wilcoxon signed-rank test) (Figure 2A & 3A). While the absolute $(0-10^{7.68} \text{ gene copies/L})$ and relative (-6.8 to 0.3 on log10 scale) levels of sul1 in 3D were consistently higher relative to 1D throughout the year-long operation of the laboratory-scale premise water supply network, the absolute $(0-10^{6.5} \text{ gene copies/L})$ and relative (-6.2 to 0.6 on log 10 scale) levels of *int*I1 in 1D and 3D were different only during the last 135 days of the operation when the levels of *int*11 in 1D slightly exceeded the levels in 3D (Figure S19A). The relative levels of *int*I1 increased over the year in 1D and decreased somewhat after the winter season in 3D (after 210 days) (Figure S19A). Under the 1D approach, the relative levels of *sul*1 correlated negatively with TOC levels (r= -0.22) (Figure 5A, Table S3), while the relative levels of *int*I1 correlated with chloride (r= 0.30) and nitrate (r=0.28) levels, and negatively with pH (r=-0.2) (Figure 5A, Table S3). In

3D, the relative levels of sul1 and intI1 in tap water did not correlate with any of the measured parameters (Figure 5B, Table S4). 3.3.2 Biofilms: The absolute levels of both sul1 and intI1 in the biofilms were higher in 3D relative to 1D: an order of magnitude higher for *sul*1 and 3 orders of magnitude higher for *int*I1 (p<0.05, One-tailed Wilcoxon signed-rank test, Figures S16B and S18B). Within the premise water supply network, the absolute levels of sul1 trended as elbows (0- 106.9 gene $copies/cm^2$) > taps (0- $10^{5.4}$ gene $copies/cm^2$) > visibly corroded pipe-sections (0- $10^{4.9}$ gene copies/cm²) in both 1D and 3D (p≤0.05, One-tailed Wilcoxon signed-rank test, Figure 2B). The absolute levels of intI1 in biofilms samples from 3D trended as elbows (0- 10^{7.9} gene $copies/cm^2$) > taps (0- $10^{5.7}$ gene $copies/cm^2$) > visibly corroded pipe sections (0- $10^{4.3}$ gene copies/cm²) (p<0.05, One-tailed Wilcoxon signed-rank test, Figure 3B). Similarly, in 1D, the absolute levels of intI1 in biofilms trended as elbows (0- 10^{5.4} gene copies/cm²) > visibly corroded pipe-sections (0– $10^{3.4}$ gene copies/cm²) > taps (0– $10^{3.2}$ gene copies/cm²) (p<0.05, One-tailed Wilcoxon signed-rank test, Figure 3B). The absolute *sul*1 and *int*I1 levels in elbows and pipe sections did not vary with the distance from the secondary storage tank under 1D and 3D approaches (Figures S13B, S13C, and S14B, S14C). The relative levels of sul1 in 1D were comparable in samples taken from visibly corroded pipe sections (-4 to 0.4 on log10 scale), elbows (-6 to 0.1 on log10 scale) and taps (-4 to -0.5 on log10 scale) at the user-end (Figure S17B), while in 3D, it trended as elbows (-7 to 0.5 on log10 scale) > visibly corroded pipesections (-6 to 0.3 on log10 scale) taps (-5 to 0.1 on log10 scale) (Figure S17B). The relative levels of *int*I1 in the biofilms in 1D trended as elbows $(-6.8 \text{ to } -0.2 \text{ on } \log 10 \text{ scale}) < \text{taps } (-4 \text{ scale}) < 10 \text{ scale}$ to -1.3 on log10 scale) and pipe-sections (-4 to -0.01 on log10 scale) (Figure S19B), and in 3D, the absolute levels of int11: taps. (-0.8 to 0.04 on log10 scale) >elbows (-7.4 to 0.04 on log 10 scale) > pipe-sections (-6.4 to -1.1 on log 10 scale) (Figure S19B).

3.4 Pathogens in the simulated water distribution system The tap water and biofilm samples were analyzed for the DNA markers of *L. pneumophila*, *M*. avium, and E. coli, amongst which only the DNA marker for L. pneumophila, mip, was detected. When detected, the *mip* gene levels in tap water were not statistically different in 1D, 3D, and building samples (p>0.05, One-tailed Wilcoxon signed-rank test, Figure S20A). However, the prevalence of mip in tap water samples trended as 1D (77/93) > 3D (70/93) >building samples (50/81). The mip levels in tap water under the 1D approach correlated with Fe (r = 0.30), Pb (r = 0.33), Cu (r = 0.27), and Zn (r = 0.32) (Figure 5A, Table S3). Whereas, under the 3D approach, the *mip* levels correlated with the levels of Fe (r=0.28), Pb (r= 0.23), Zn (r= 0.27), and sulphate (r= -0.30) (Figure 5B, Table S4). The mip levels changed significantly throughout the year in both 3D and 1D, similar to the variations observed in the building samples (Bhaskar and Singh, 2021) (Figure 4A). During the winter season, both the 1D (24/93) and 3D (20/93) approaches had a much higher prevalence of mip relative to the building samples 6% (2/31) (Figure 4A). During summer and monsoon seasons, the prevalence of mip was in 1D, and 3D was comparable to the building samples. The levels of mip in the biofilm samples were similar in both 1D (0- 10^{5.55} gene copies/cm²) and 3D (0- 10^{5.5} gene copies/cm²) (p<0.05, One-tailed Wilcoxon signed-rank test, Figure S20B), and trended as elbows (0- $10^{5.5}$ gene copies/cm²) > pipe-sections (0- $10^{5.3}$ gene copies/cm²) > taps (0- $10^{3.9}$ gene copies/cm²) (p<0.05, One-tailed Wilcoxon signed-rank test) (Figure 4B). In 1D biofilms, the absolute mip levels correlated with absolute sul1 levels (r=0.30), whereas in the tap water, the levels of mip gene under the 1D approach negatively correlated with absolute levels of sul1 (r=-0.29). Only in 1D elbows, the absolute mip correlated with the distance of the elbow from the secondary storage tank (r=0.61) (Figure 5A).
