Two-Year Evaluation of *Legionella* in an Aging Residential Building: Assessment of Multiple Potable Water Remediation Approaches

16 SYNOPSIS: Long-term *Legionella* control is difficult to maintain within aging premise
17 plumbing. This study supports continuous low-level building treatment as an effective long-term
18 remediation of a building highly colonized with *Legionella*.

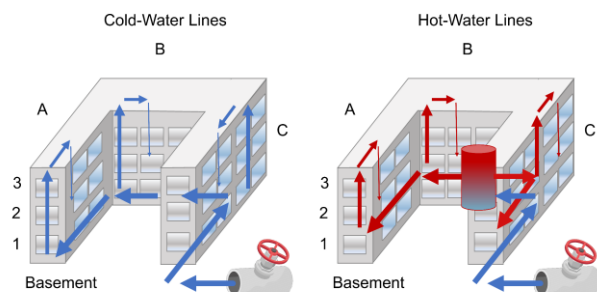
118
119 **Figure 1.** Building hydraulic flow of cold-water entering from the Drinking Water Distribution
120 System (DWDS), hot-water heating, and flow. (Left) The cold-water from the DWDS enters
121 through Riser C in the Basement and flows into Riser B and then Riser A, the cold-water then
122 rises to the top 3rd Floor and descends to the 2nd and 1st Floors. (Right) The hot-water is heated
123 first in a 4,000 L heat tank located in Riser B in the Basement. After heating, the hot-water flows
124 to Risers A & C simultaneously, then rises to the 3rd Floor and descends to the 2nd and 1st
125 Floors. The hot-water recirculates throughout the building's main hot-water lines.

103 **Site Selection.** Treatment interventions occurred in a residential building with known
104 colonization of *Legionella* on an educational campus in Maryland, USA. This building, denoted
105 Building A, experienced limited water-use with no occupancy from March 2020 to January 2021
106 due to the COVID-19 pandemic building shutdown implemented in March 2020. From January
107 2021 to May 2021, the building was partially re-occupied and full occupancy was initiated in
108 September 2021. Building A was built in the mid-1950s and is comprised of four floors
109 (Basement, Floor 1, Floor 2, Floor 3) and three wings i.e., risers (Riser A, Riser B, Riser C). A

110 4,000 L water heater tank located in the Basement of Riser B heats and stores the building's hot
111 water. The hot water was distributed in a recirculating system from the top to bottom floors
112 (Figure 1). Twelve showers were selected for hot water sampling with at least three showers
113 selected for Floors 1-3 and each riser. Cold-water was sampled from the basement (main line
114 entry from the DWDS located in the Basement in Riser C) and two sink faucets that were most
115 proximal and distal from the main line entry. The building's potable water was supplied by the
116 metropolitan drinking water utility which treats surface water for municipal use and distributes
117 the water using chlorine for disinfectant residual throughout an urban environment.

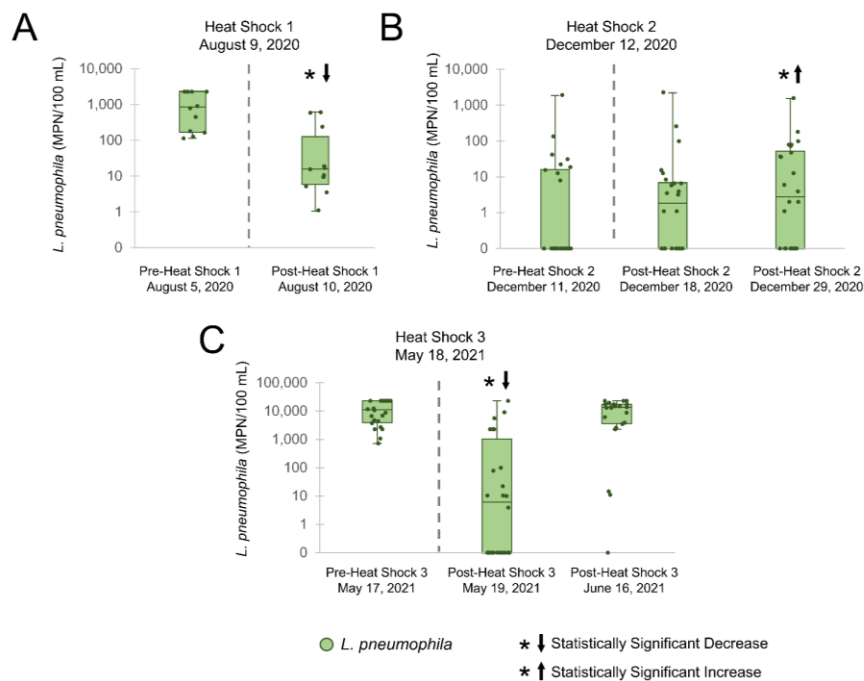
247 **Figure 3.** Single heat shock treatments conducted in Building A. Hot-water samples were
248 compared using Wilcoxon Signed Rank Test on paired *L. pneumophila* shower results. (A)
249 Samples (n=12) were compared for reduction of *L. pneumophila* four days prior (Pre-Heat Shock
250 1) to one day after (Post-Heat Shock 1) treatment conducted on August 9, 2020 (Heat Shock 1).
251 (B) Samples (n=24) were compared for reduction on *L. pneumophila* one day prior (Pre-Heat
252 Shock 2) to six days after (Post-Heat Shock 2) and two weeks after (Post-Heat Shock 2)
253 treatment conducted on December 12, 2020 (Heat Shock 2). (C) Samples (n=24) were compared
254 for reduction of *L. pneumophila* one day prior (Pre-Heat Shock 3) to one day after (Post-Heat
255 Shock 3) and four weeks after (Post-Heat Shock 3) treatment conducted on May 18, 2021 (Heat
256 Shock 3). *↓ There was a statistically significant decrease in *L. pneumophila* compared to

257 samples prior to treatment. *↑ There was a statistically significant increase *L. pneumophila*
258 compared to samples prior to treatment.

235 after treatment (August 10, 2020) (Figure 3A). *L. pneumophila* concentrations remained constant
236 afterwards four months later (December 11, 2020) ($p=0.21$). The analysis for Heat Shock 2 did
237 not find a significant reduction in *L. pneumophila* ($p=0.87$) between samples collected one day
238 prior (December 11, 2020) and six days after treatment (December 18, 2020) (Figure 3B). There
239 was a significant 0.20 log increase of *L. pneumophila* comparing samples prior to Heat Shock 2
240 (December 11, 2020) and two weeks after treatment (December 29, 2020) ($p=0.05$) (Figure 3B).
241 For Heat Shock 3, samples collected one day prior (May 17, 2021) and one day after treatment
242 (May 19, 2021) experienced a significant 1.53 log reduction of *L. pneumophila* ($p<0.001$), but
243 comparison of pre-Heat Shock 3 samples to those four weeks after treatment (June 16, 2021)
244 found no significant difference in *L. pneumophila* concentrations ($p=0.92$) (Figure 3C).

378 **Prolonged Stagnation and Building Treatments.** Building A experienced extended stagnation
379 for nine months from March 2020 to December 2020 and in response, building managers
380 implemented interventions in the hot and cold-water lines in accordance with the CDC's
381 published guidance to reduce *Legionella*.^{11,30,48} Heat Shock 1 and Heat Shock 2 resulted in a
382 reduction *L. pneumophila* short-term, however prolonged water stagnation may have exacerbated
383 growth weeks later (Figure 3A and Figure 3B).⁴⁹ The building was partially re-occupied on
384 January 13, 2021, after the shutdown, and with the return of partial water-use in the building, *L.*
385 *pneumophila* concentrations substantially rose months later (Figure 2). Heat Shock 3 resulted in
386 a short-term reduction of *L. pneumophila* then a rapid return to pre-heat shock levels in majority
387 of sampling sites in the building (Figure 3C). Guidance from the American Water Works

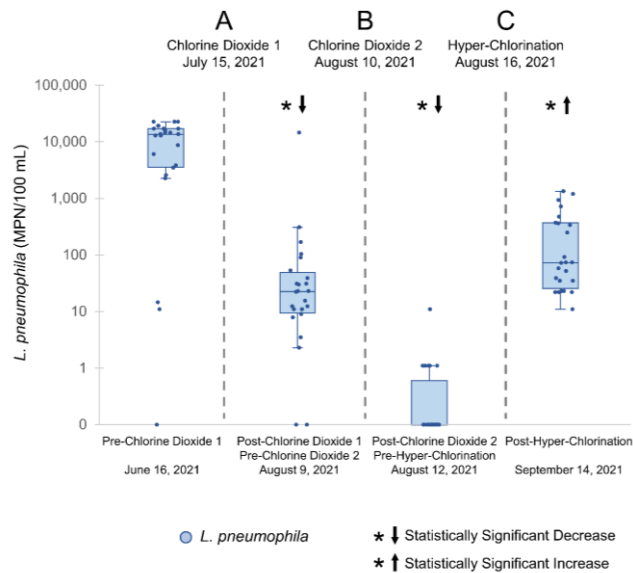
270 **Figure 4.** Single chemical shock treatments conducted in Building A. Hot-water samples were
271 compared using Wilcoxon Signed Rank Test on paired *L. pneumophila* shower results. (A)
272 Samples (n=24) were compared for reduction on *L. pneumophila* four weeks prior (Pre-Chlorine
273 Dioxide 1) to three weeks after (Post-Chlorine Dioxide 1) treatment conducted on July 15, 2021
274 (Chlorine Dioxide 1). (B) Samples (n=24) were compared for reduction of *L. pneumophila* one
275 day prior (Pre-Chlorine Dioxide 2) to two days after (Post-Chlorine Dioxide 2) treatment
276 conducted on August 10, 2021 (Chlorine Dioxide 2). (C) Samples (n=24) were compared for
277 reduction of *L. pneumophila* four days prior (Pre-Hyper-Chlorination) to four weeks after (Post-
278 Hyper-Chlorination) treatment conducted on August 16, 2021 (Hyper-Chlorination). *↓ There
279 was a statistically significant decrease in *L. pneumophila* compared to samples prior to

280 treatment.*↑ There was a statistically significant increase *L. pneumophila* compared to samples
281 prior to treatment.

259 *Single Chemical Shock Treatments.* Chemical shock treatments were conducted and evaluated
260 after the multiple single Heat Shock treatments failed to provide long-term reduction for *L.*
261 *pneumophila*. Analysis of Chlorine Dioxide 1 samples collected four weeks prior (June 16, 2021)
262 to four weeks after (August 9, 2021) treatment found a significant 2.29 log reduction of *L.*
263 *pneumophila* ($p < 0.001$) (Figure 4A). Results for Chlorine Dioxide 2 found a significant 1.29 log
264 reduction of *L. pneumophila* ($p < 0.001$) between samples collected one day prior (August 9,
265 2021) and two days after treatment (August 12, 2021) (Figure 4B). Comparison of samples
266 collected four days prior to Hyper-Chlorination (August 12, 2021) and four weeks after
267 (September 14, 2021) found a significant 1.80 log increase in *L. pneumophila* ($p < 0.001$) (Figure
268 4C).

388 Association (AWWA) does not recommend heat shock treatments due to the rapid bounce back
389 of *Legionella* concentrations.⁵⁰ The heat resilience within biofilms may have also contributed to
390 the *L. pneumophila* resurgence after heat shock treatments.⁵⁰ After the single heat shocks failed
391 to control *L. pneumophila*, building operators turned to chemical disinfection to treat the hot and
392 cold-water systems. The first chlorine dioxide treatment (Chlorine Dioxide 1) was effective in
393 reducing *L. pneumophila* and the subsequent chlorine dioxide treatment (Chlorine Dioxide 2)
394 further temporarily ablated *L. pneumophila* to levels below detection (Figure 4A and 4B). An
395 additional chlorination shock (Hyper-chlorination) was conducted to further eradicate *L.*
396 *pneumophila* from the system but experienced an increase of *L. pneumophila* weeks later (Figure

397 4C). A possible explanation for *L. pneumophila* resurgence could be the detachment of biofilm
398 resulting from the chlorine shocks.⁵¹ As the building transitioned back to limited water-use from
399 short term vacancy (December 7, 2021 to January 12, 2022), *L. pneumophila* concentrations
400 increased further (Figure 2). The limited use may have resulted in water stagnation that may have
401 contributed to further biofilm formation within the pipes.⁵² As a response to the failure of single
402 chemical treatments on long-term *L. pneumophila* control, building managers shifted to
403 evaluating a continuous low-level chemical treatment approach. This decision was made to
404 provide continuous chemical treatment at levels that were safe for building occupants.⁵³ After the
405 implementation of the continuous low-level chlorine dioxide treatment, *L. pneumophila*
406 concentrations stabilized and finally reduced months after the implementation of treatment

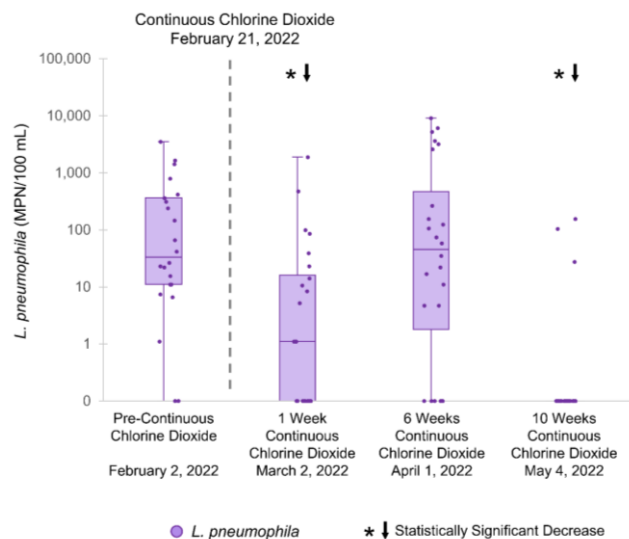
292 **Figure 5.** Continuous low-level chlorine dioxide treatment implemented in Building A. Hot-
293 water samples were compared using Wilcoxon Signed Rank Test on paired *L. pneumophila*
294 shower results (n=24). Samples were compared for reduction of *L. pneumophila* three weeks
295 prior (Pre-Continuous Chlorine Dioxide) to one week, six weeks, and ten weeks after treatment
296 implemented on February 21, 2022 (Continuous Chlorine Dioxide). *↓ There was a statistically
297 significant decrease in *L. pneumophila* compared to Pre-Continuous Chlorine Dioxide samples.

285 (February 2, 2022) and one week later (March 2, 2022) found a significant 0.58 log reduction in
286 *L. pneumophila* ($p < 0.001$) (Figure 5). Six weeks after implementation (April 1, 2022), *L.*
287 *pneumophila* concentrations returned to pre-implementation levels ($p = 0.13$). Ten weeks after
288 implementation (May 4, 2022), there was a significant 0.79 log reduction in *L. pneumophila*
289 ($p < 0.001$) (Figure 5).

407 (Figure 5). Since the levels of continuous chlorine dioxide treatments were low compared to
408 shock treatments, it may have taken months longer to experience the full effect of the
409 disinfection. Our findings are similar to several studies that have also shown the long-term
410 effectiveness of continuous chlorine dioxide treatment in potable water systems.^{54,55}
