Toilets dominate environmental detection of SARS-CoV-2 virus in a hospital

Background: Respiratory and faecal aerosols play a suspected role in transmitting the SARS-CoV-2 virus. We performed extensive environmental sampling in a dedicated hospital building for Covid-19 patients in both toilet and non-toilet environments, and analysed the associated environmental factors.

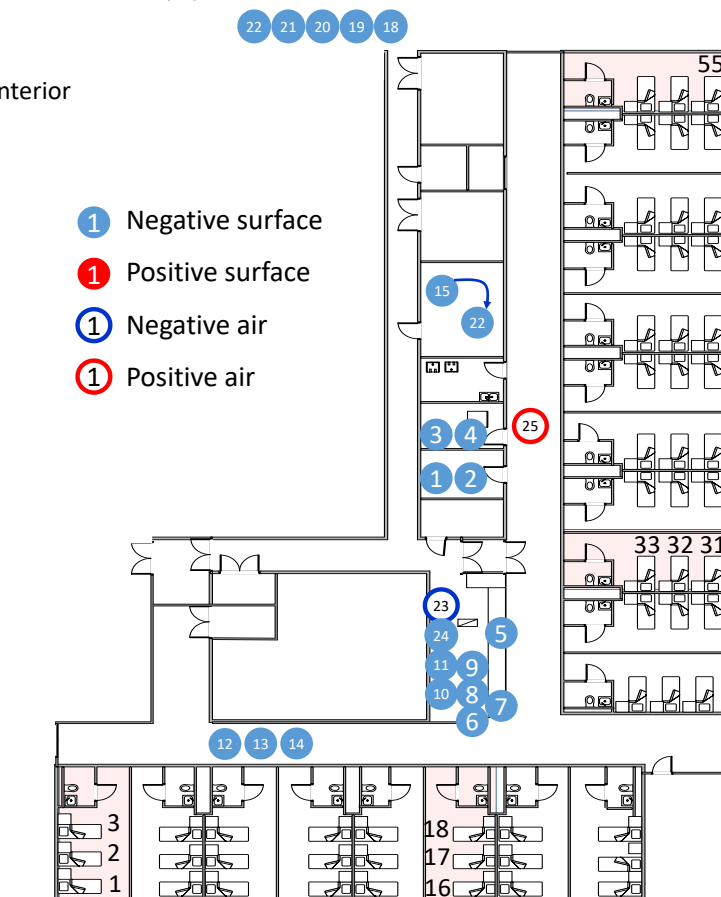
1. cleaner's: mop
2. squeeze mop
3. Storage room: medical waste-bin (interior surface)
4. medical waste-bin pedal
5. nursing station: front desk
6. door handle
7. disinfectant-station button
8. computer keyboard
9. operating clinical desk
10. phone
11. hand-disinfectant spray button
12. corridor: nurses' trolley handle
13. nurses' tray
14. handrail
15. change room: desk
16. Floor
17. hand-disinfectant spray button
18. waste-bin interior surface
19. waste-bin pedal
20. washbasin sink
21. washbasin flange
22. washbasin surface
23. nursing station: below air-supply inlet (air)
24. nursing station: below air-supply inlet (surface)
25. corridor outside storage room

Figure 1. Summary of the sites where the air and surface samples were taken in the hospital. (A) In the air-conditioning systems of the isolation rooms and on the building roof. The highlighted area in red is the airborne infectious disease zone on the 5th floor; (B) at the nursing station, storage/cleaner’s rooms, healthcare workers’ PPE changing room, and corridor; and (C) in the isolation rooms, but note that in some of the rooms, fewer surface and air samples were taken than are shown here. The positive samples are shown by either empty circle in red or filled circle in red. The negative samples are shown by either empty circle in blue or filled circle in blue. In Figure 1B, the four sampled rooms are highlighted in light red, i.e. isolation rooms containing beds 2 and 3, beds 16-18, beds 31 and 32, and bed 55.

The sites for the air and surface samples are shown in [Figure 1](#). All samples were collected by a trained CDC officer who had a medical background, assisted by two trained nurses from the hospital. The CDC officer wore full personal protective equipment (PPE), namely an N95 respirator, goggles, face shield, gloves, shoe covers, cap, and gown. He was quarantined for 12 days after the collection on 8 February, disinfected, and resumed sampling on 20 and 22 February. Thereafter he was quarantined again for another 14 days, and again disinfected.

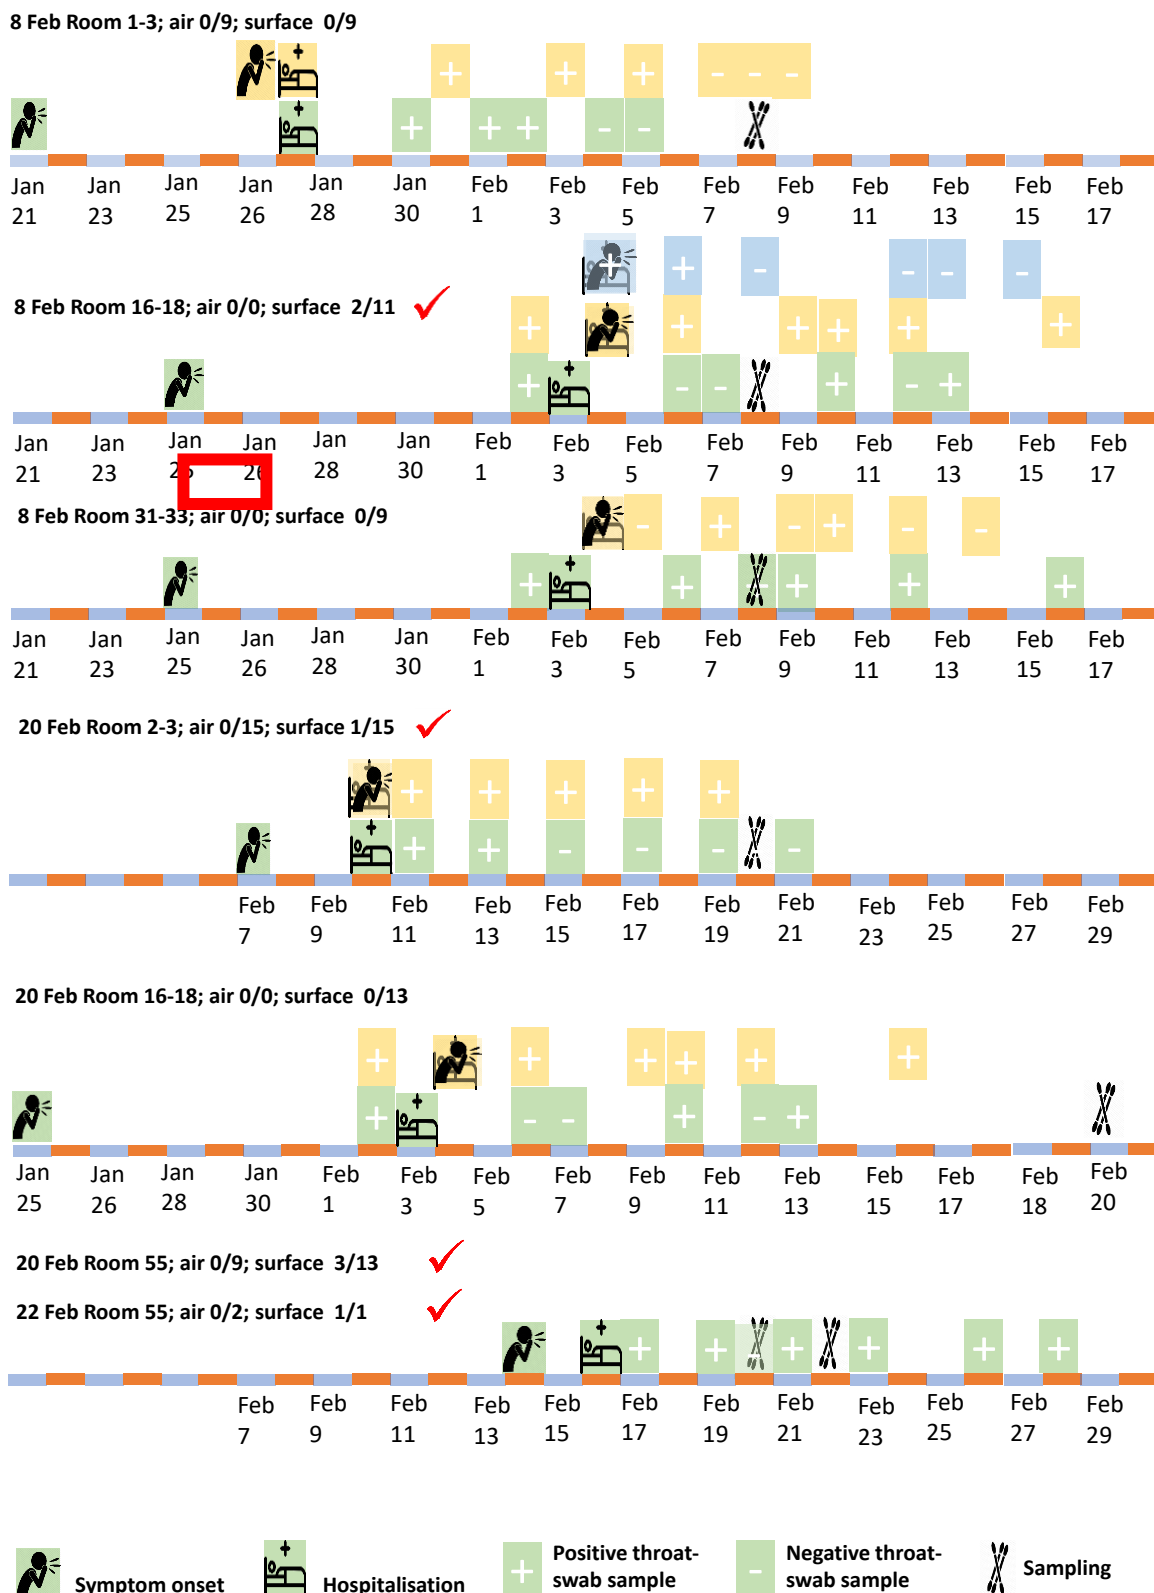
Figure 2. Summary of the isolation rooms containing beds 2 and 3, beds 16-18, beds 31 and 32, and bed 55, and their 10 patients (onset and hospitalisation dates), and the sampling dates. The sampling dates on which positive samples were detected are also shown by a red tick. In each room, a patient and his/her bed are shown in the same colour. When events occurred on the same day, such as symptom onset and hospitalisation, the symbols overlap and are shown in transparent style.

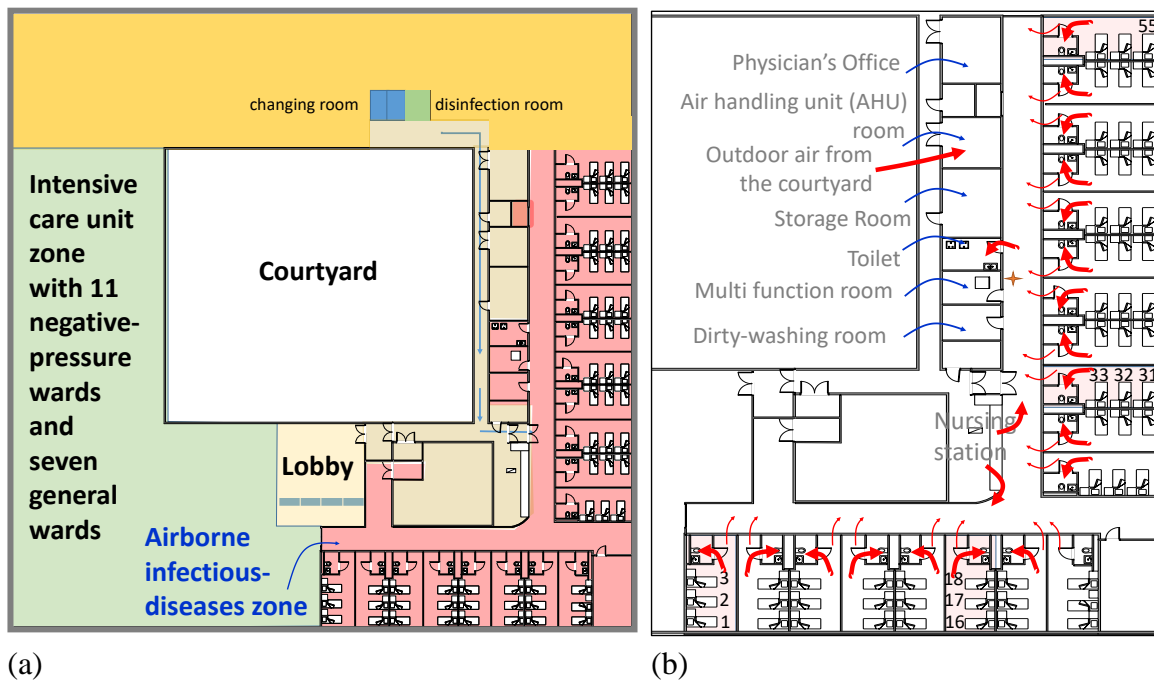
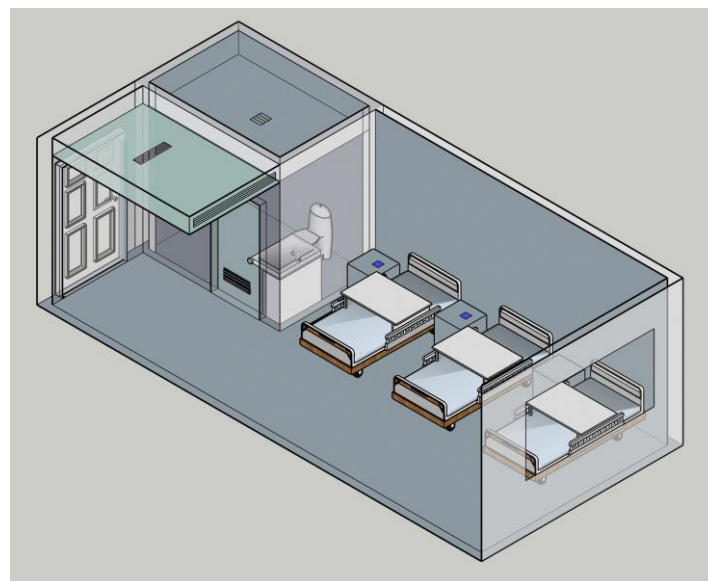
Figure S1. (a) Floor plan of the fifth floor of the hospital, with the airborne infectious-disease zone shown in transparent pink. (b) Floor plan of the airborne infectious-disease zone showing the location of the sampled isolation rooms (with beds 1-3; beds 16-18; beds 31-33; bed 55 shown), nursing station, and other rooms. The general airflow pattern is shown by red arrows. (c) Three-dimensional perspective view of the isolation room, showing the location of various objects.
